INSPECTION REPORT

For the Property at:
2720 ACADEMY RD
LEBANON , TN 37087

Prepared for: JOHN DOE
Inspection Date: Thursday, October 23, 2014
Prepared by: Harold Shelby

RE: Report No. 1018, v.2
2720 Academy Rd
Lebanon , TN
37087

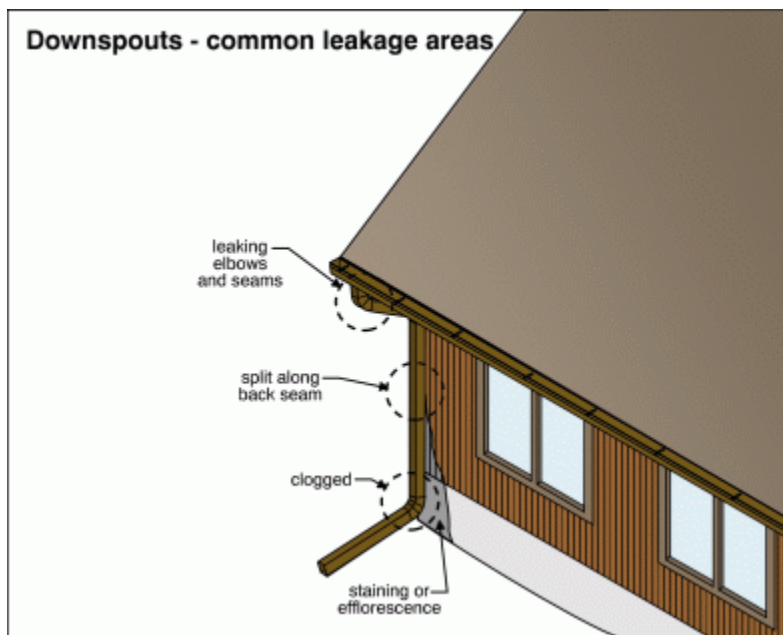
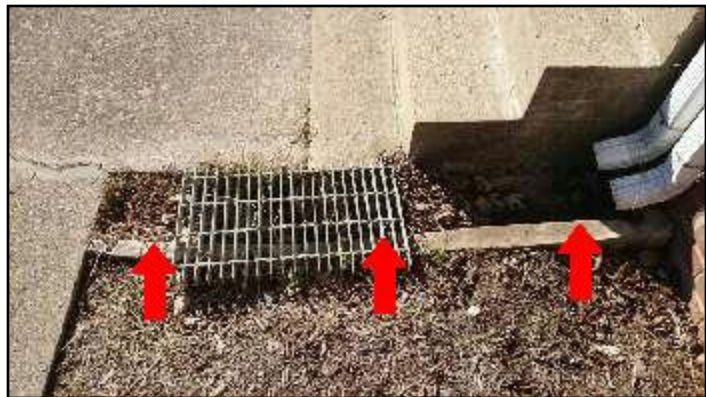
1. Condition: • [Clogged](#)

Implication(s): Chance of water damage to contents, finishes and/or structure

Location: Southeast

1. Clogged

Recommend cleaning this to allow discharge to drain properly away from foundation.

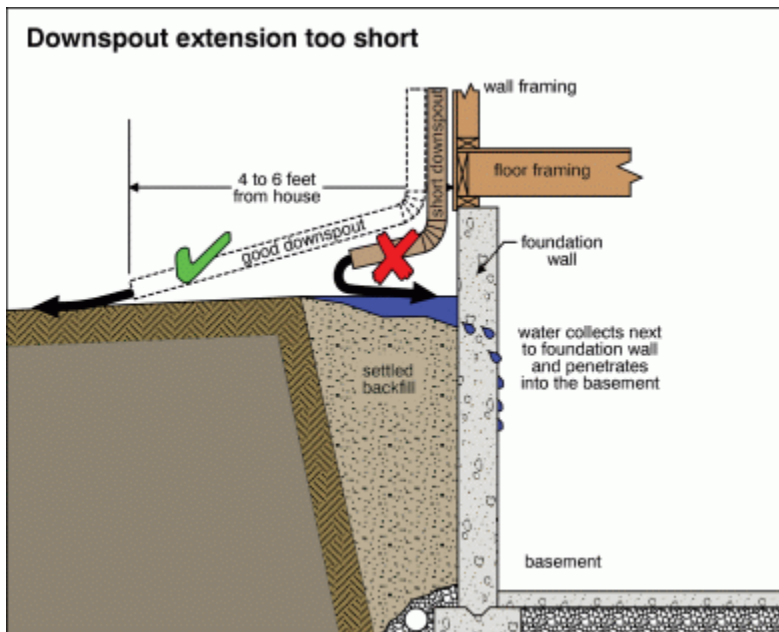
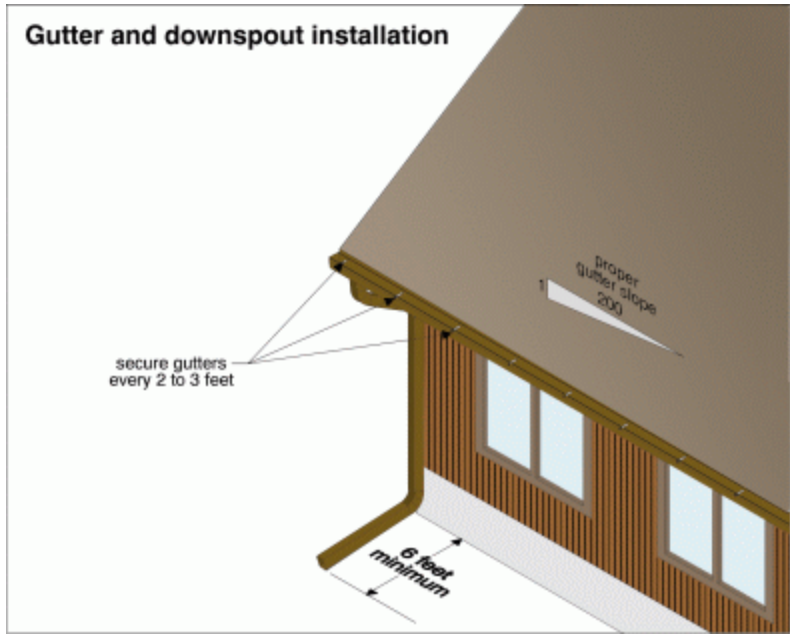
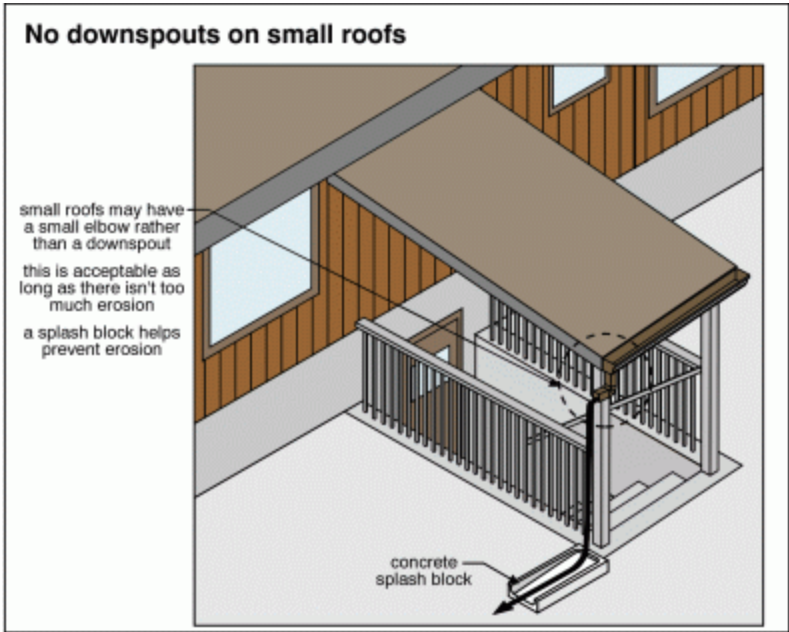
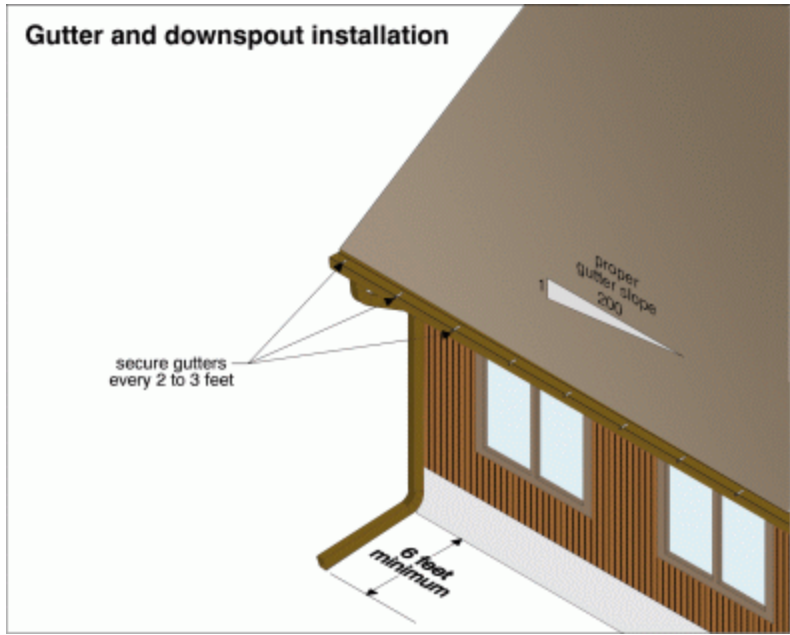
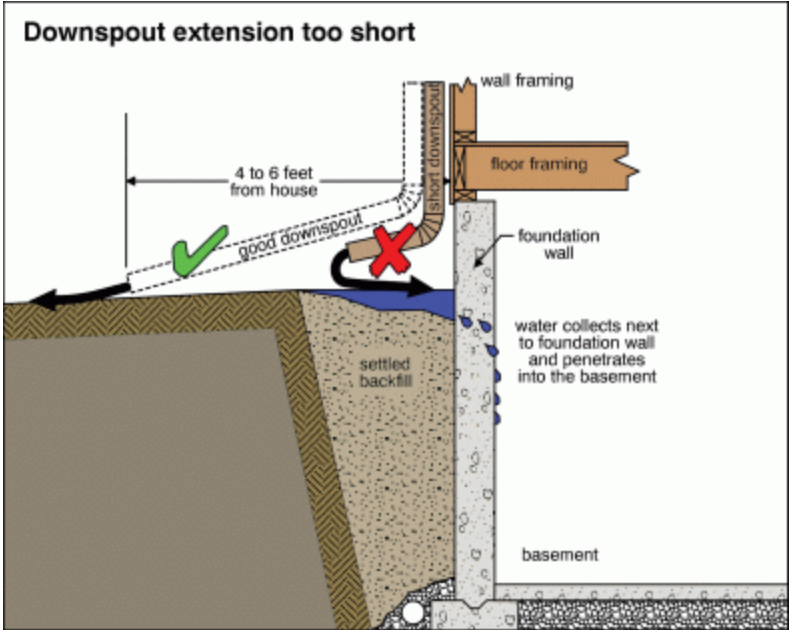
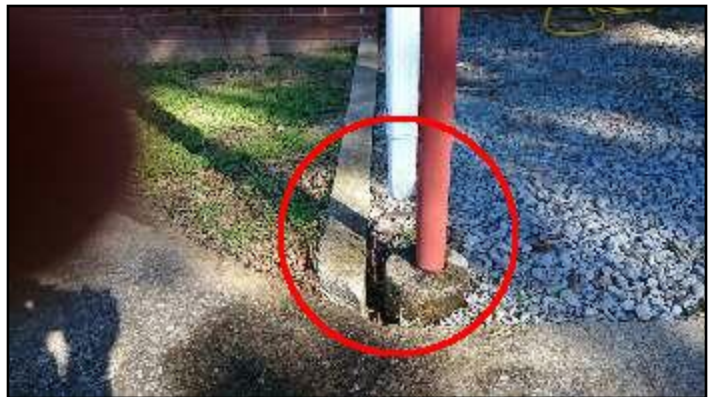
2. Condition: • [Should discharge 6 feet from building](#)

Implication(s): Chance of water damage to contents, finishes and/or structure

Location: South

2. Should discharge 6 feet from building

Recommend extending downspout discharge 5' to 6' from foundation.

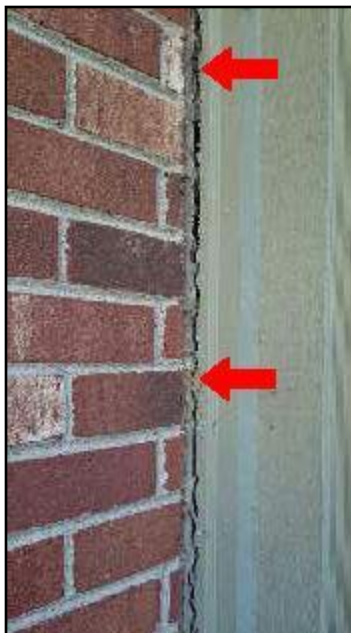
3. Condition: • [Caulking missing or ineffective](#)

Implication(s): Chance of water damage to contents, finishes and/or structure

Location: First Floor Dining Room

3. Caulking missing or ineffective

Recommend caulking between the wood siding and brick garage wall. This is at the front of the house where wood siding meets brick garage wall.

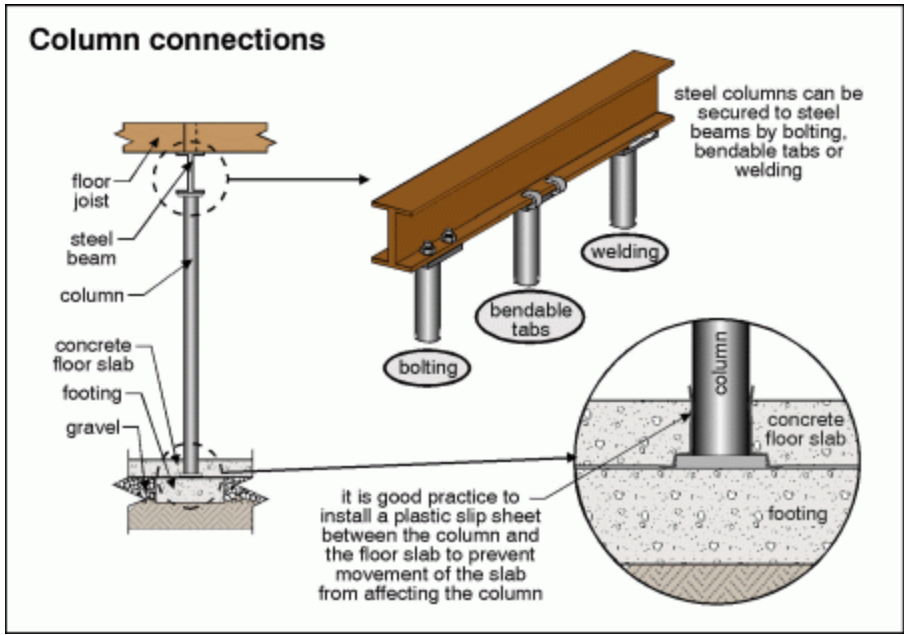
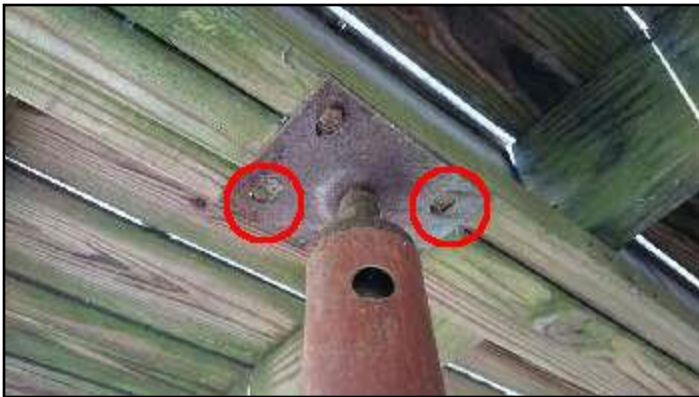
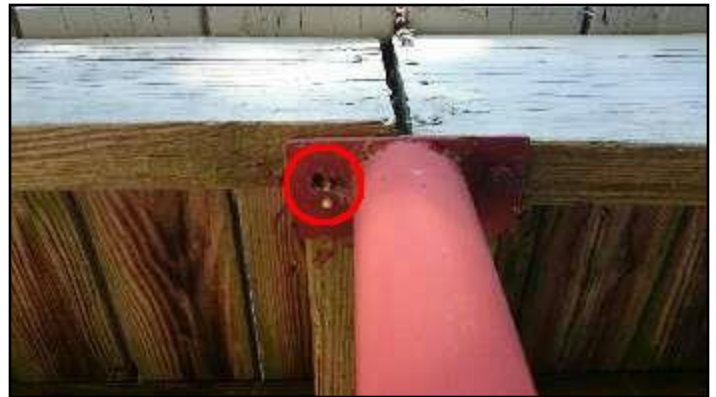
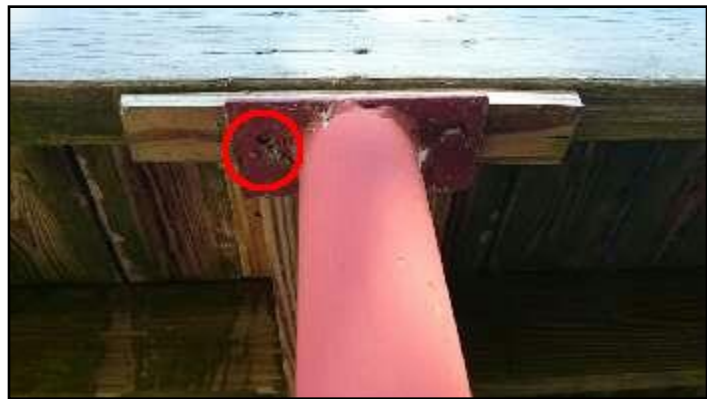
4. Condition: • Recommend columns be attached properly. These columns are missing at least one lag screw.

Location: Deck

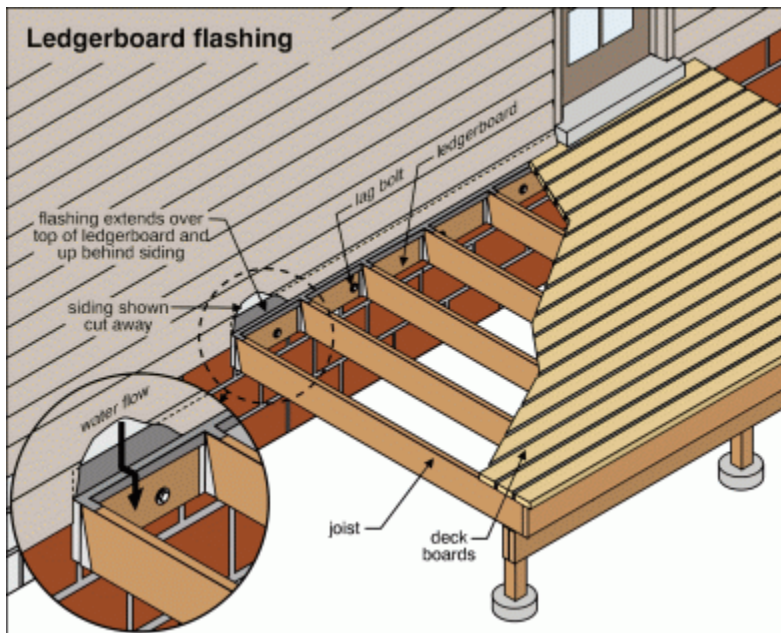
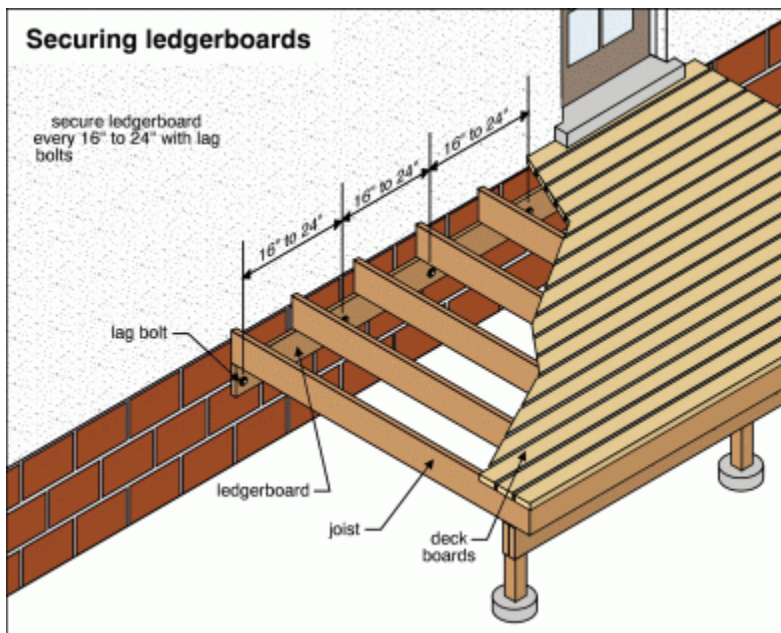
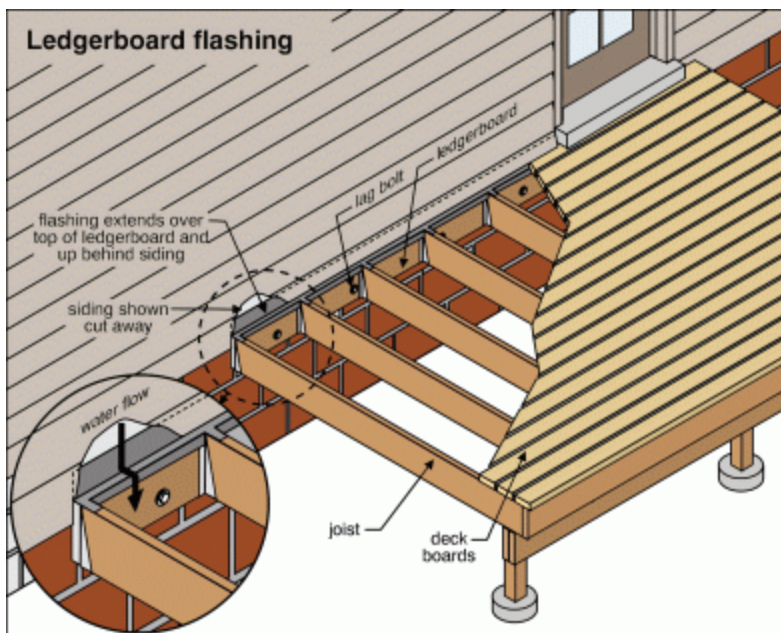
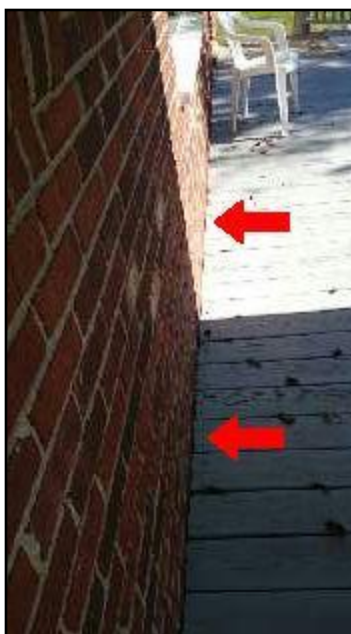
5. Condition: • [Missing flashing at deck connection](#)

Implication(s): Weakened structure | Chance of movement

Location: Deck

7. Missing flashing at deck connection

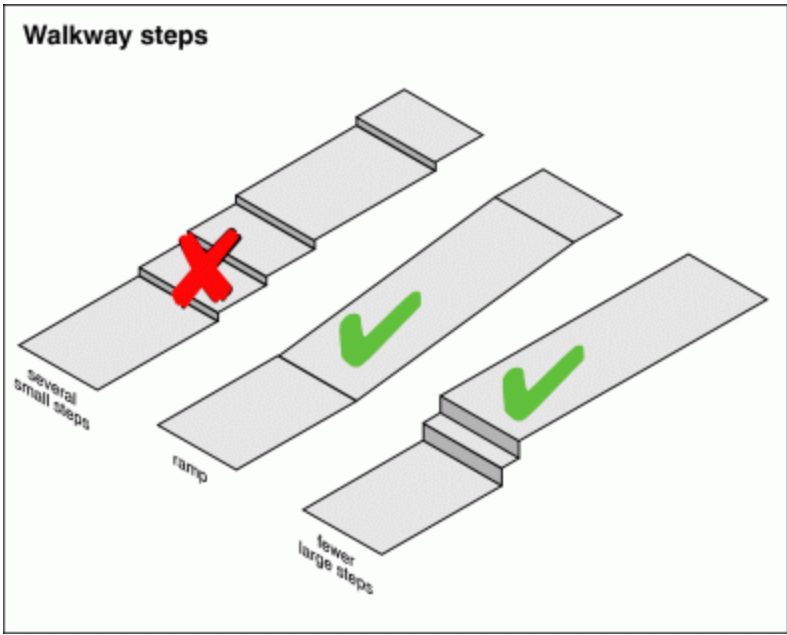
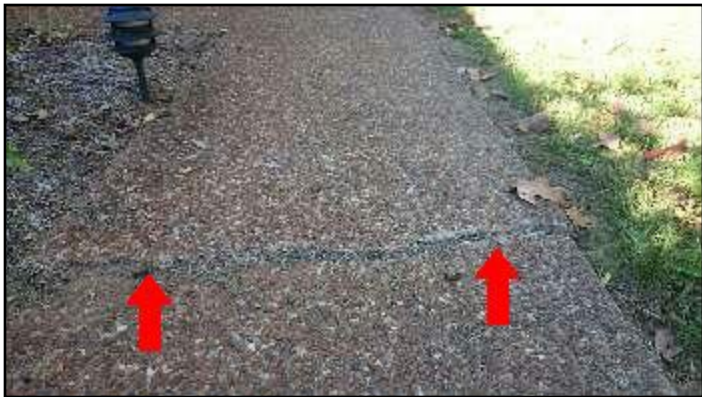
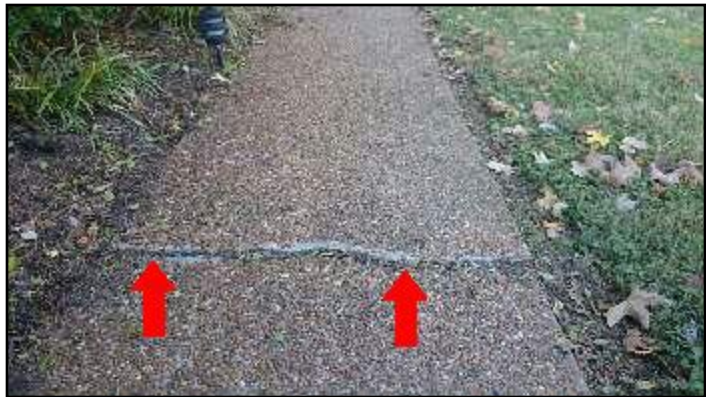
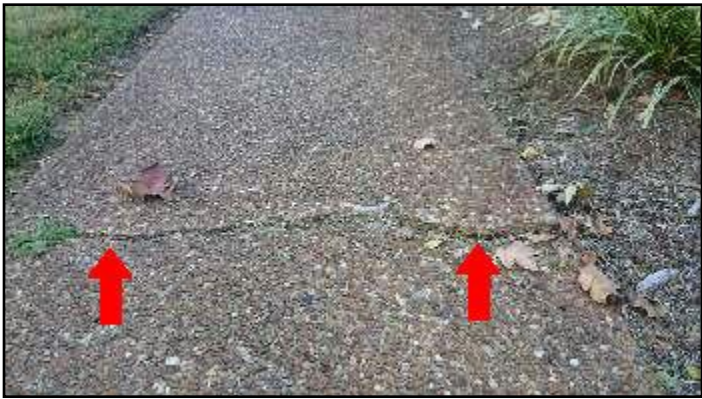
Implication(s): Trip or fall hazard

7. Condition: • [Uneven \(trip hazard\)](#)

This is a safety concern it is a trip hazard. The front walkway has 3 cracks that have settled leaving a rise on one side. Recommend repair.

8. Uneven (trip hazard)

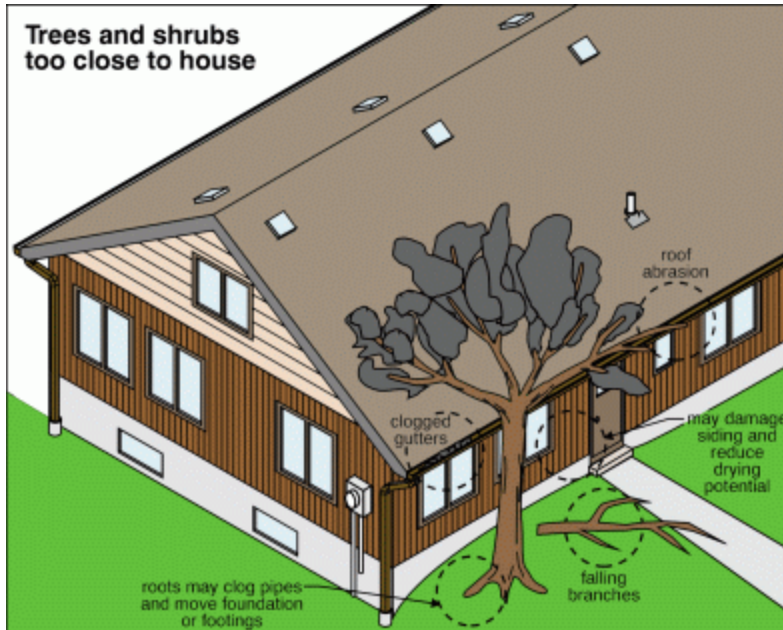
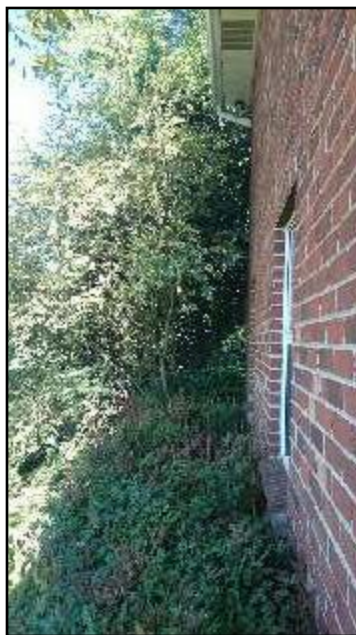
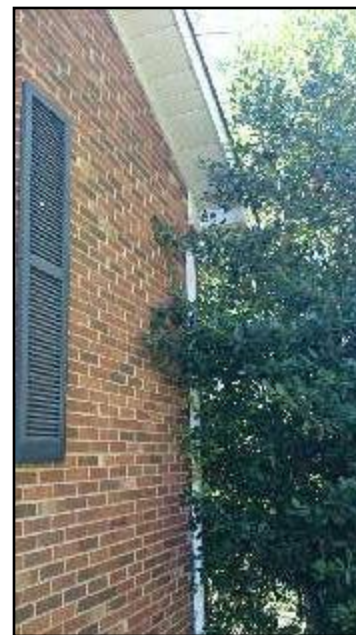
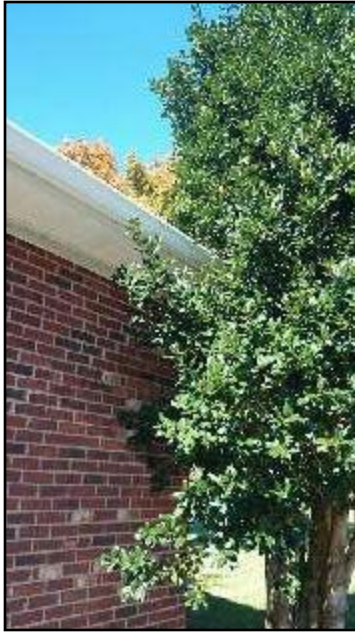
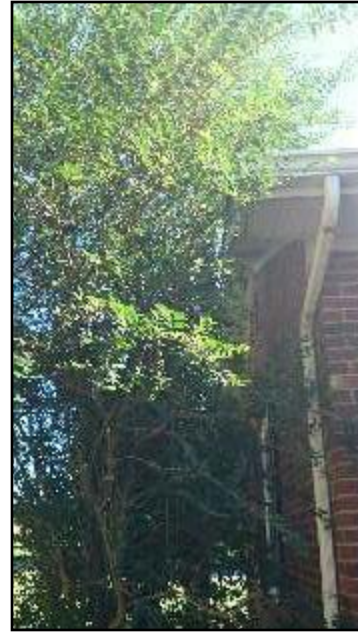
8. Condition: • [Trees or shrubs too close to building](#)
Recommend trees and shrubbery be trimmed back away from house.

Implication(s): Chance of water damage to contents, finishes and/or structure | Chance of pests entering building | Material deterioration
Location: Various

11. Trees or shrubs too close to building

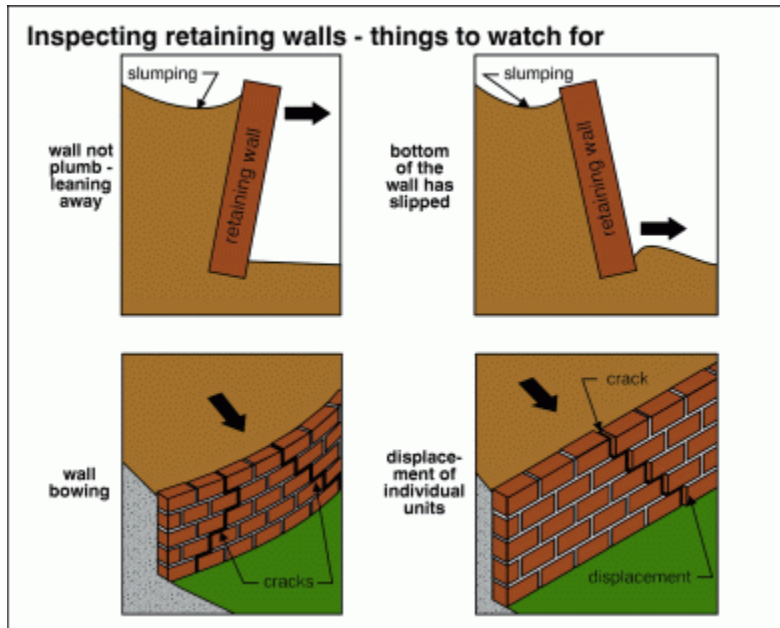
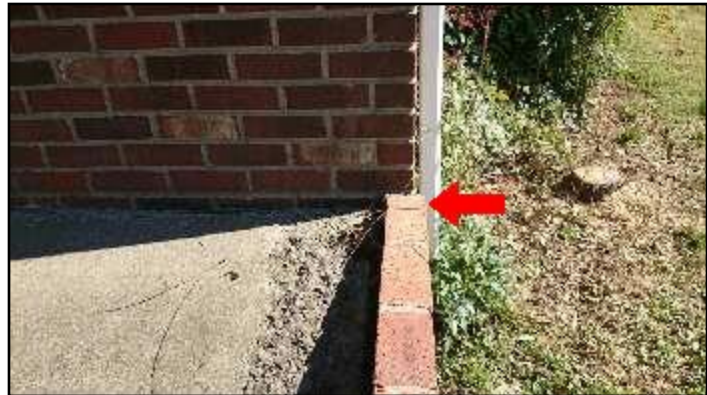
9. Condition: • [Leaning](#)

15. Leaning

Recommend this be evaluated by structural engineer. The wall is leaning.

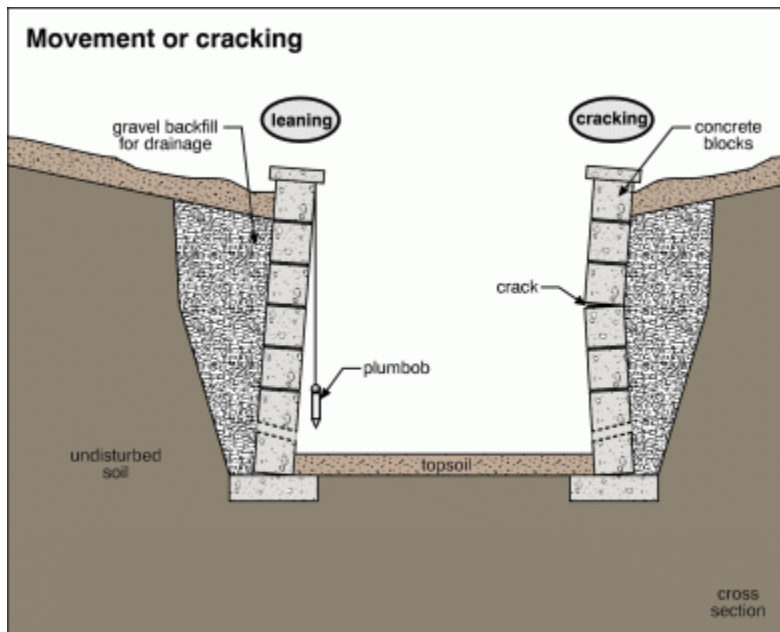
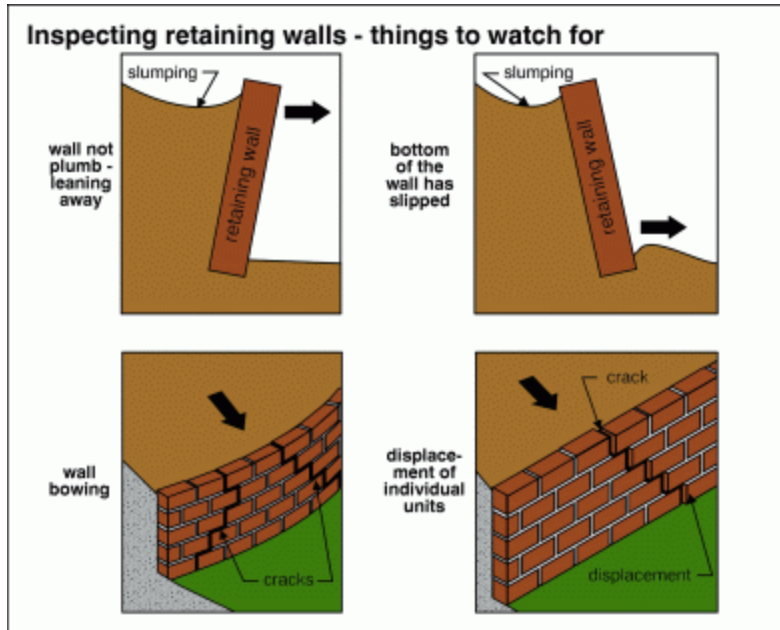
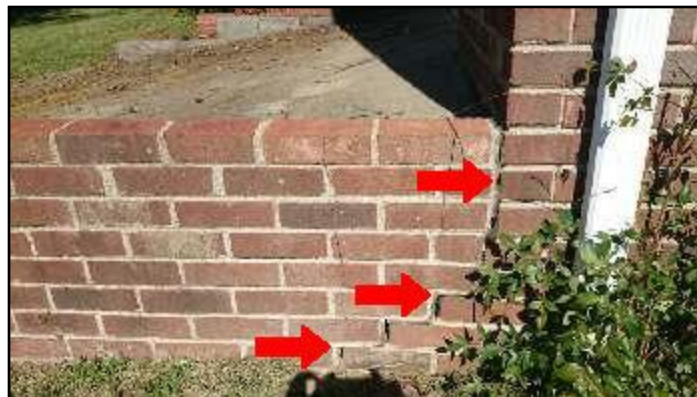
10. Condition: • [Settling or shifting](#)

Location: Southwest

16. Settling or shifting

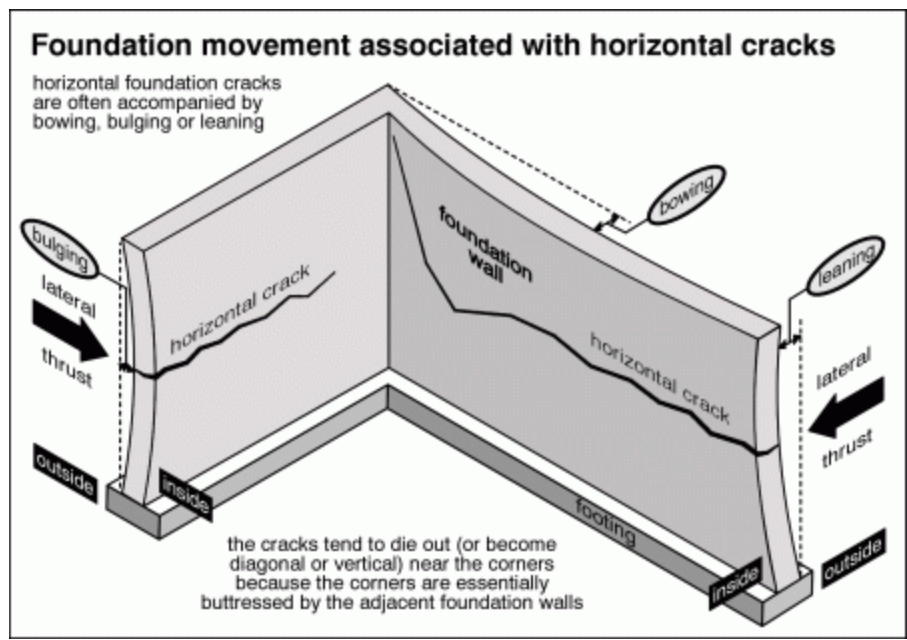
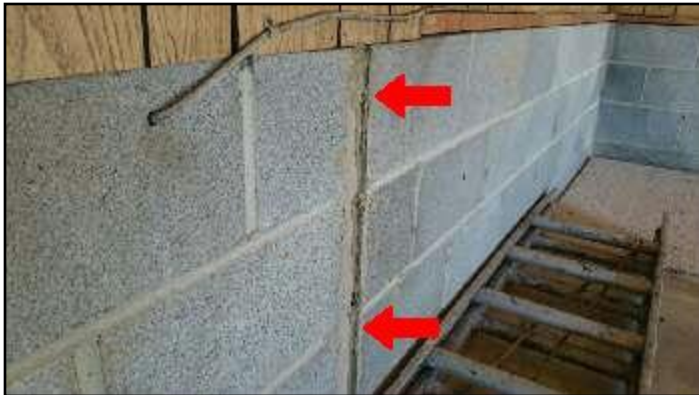
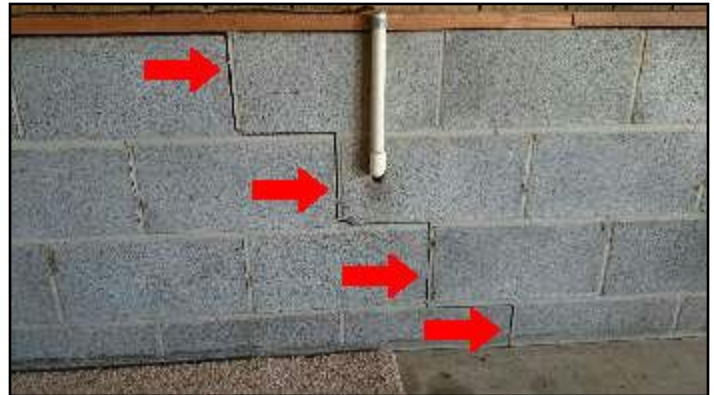
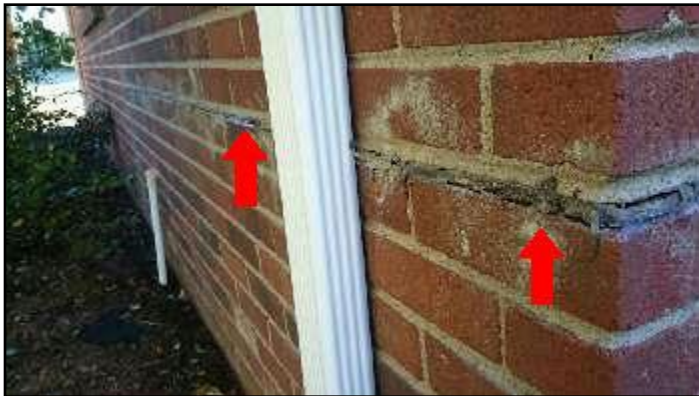
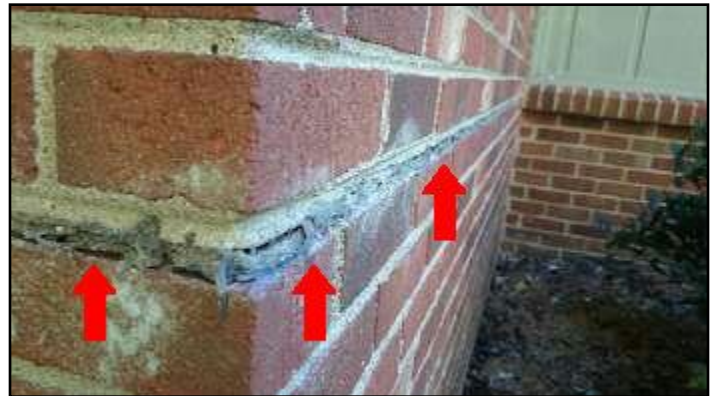
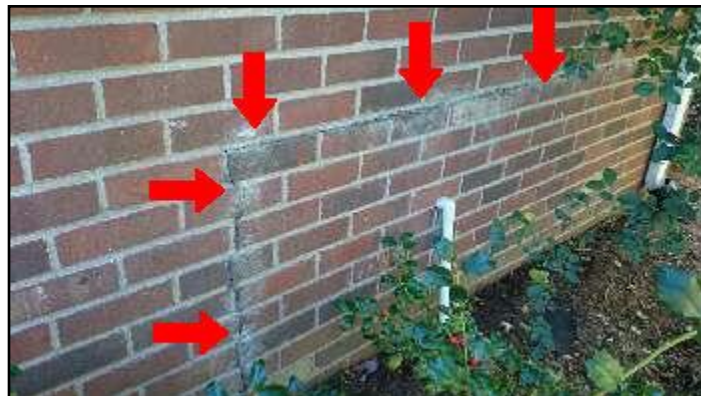
- 11. Condition:** • Further evaluation required
Recommend structural engineer evaluate further.
- Implication(s):** Chance of structural movement
- Location:** Garage
- Task:** Further evaluation
- Time:** Immediate

17. Further evaluation required

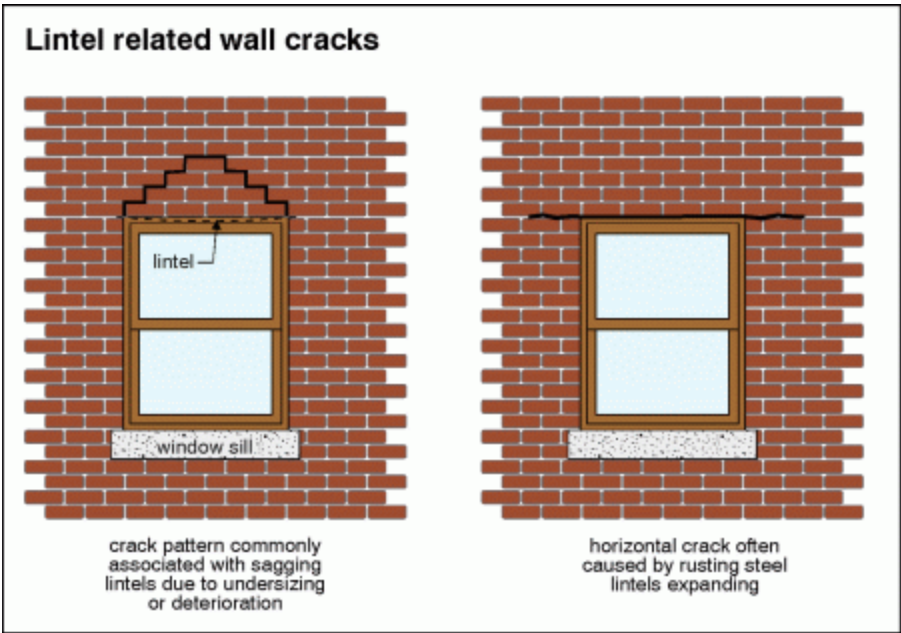
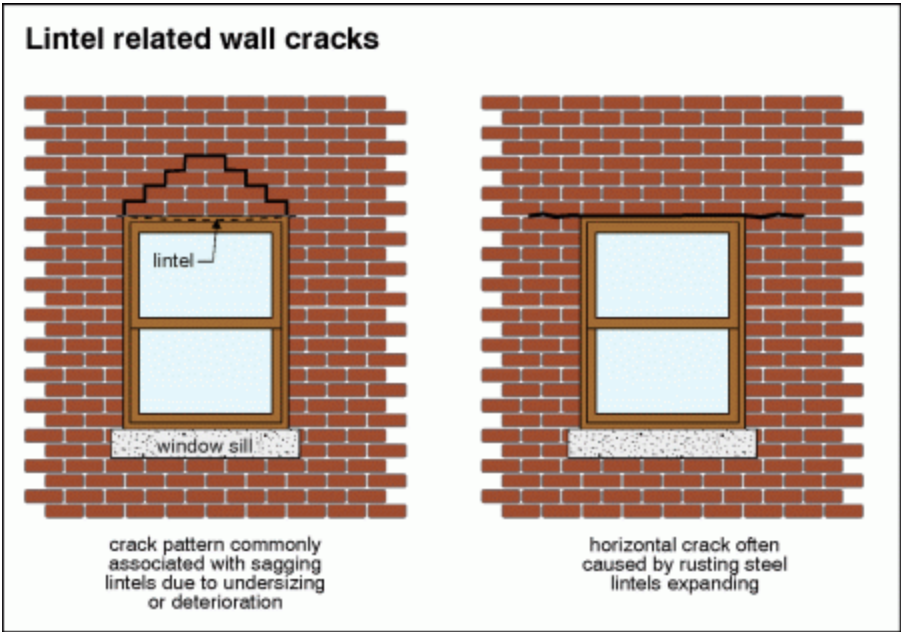
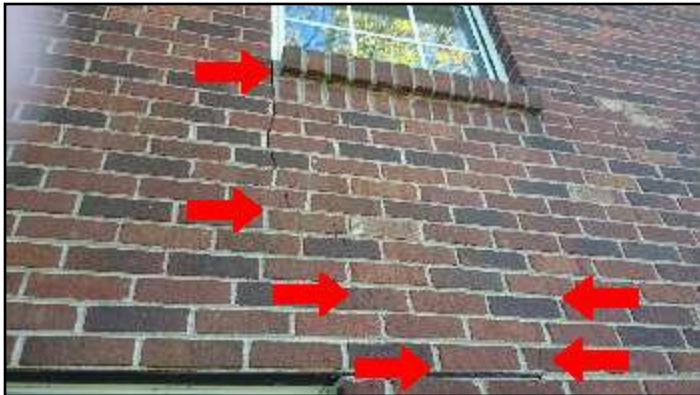
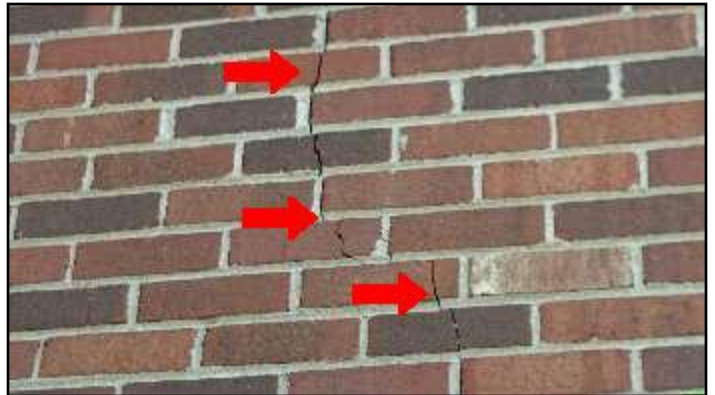
12. Condition: • [Rust](#)

22. Rust

Recommend structural engineer evaluate further.

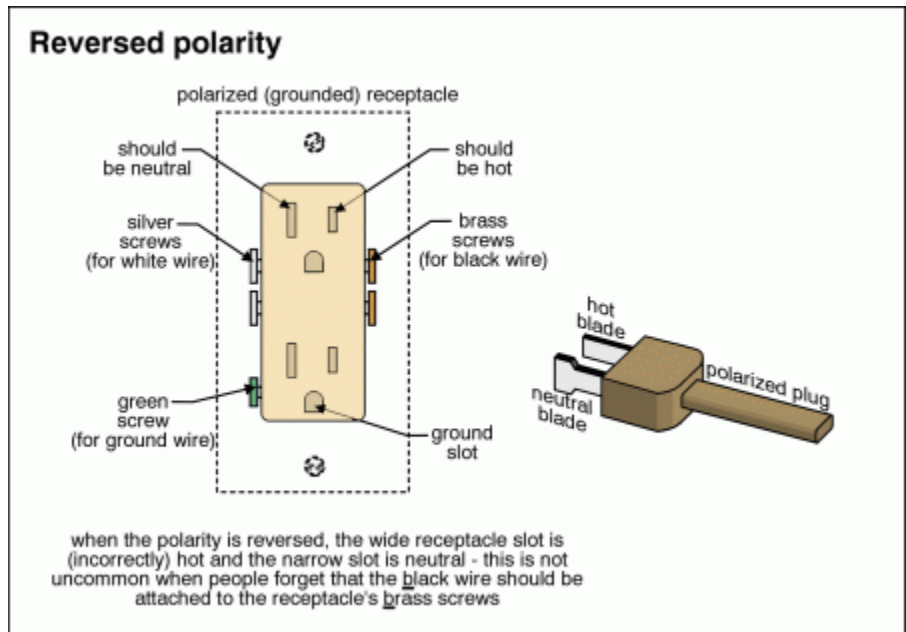
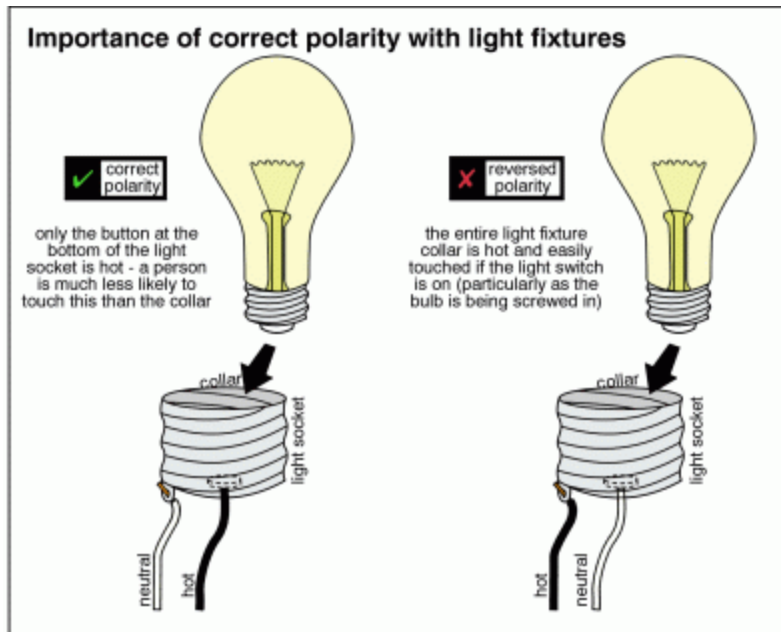
13. Condition: • [Reversed polarity](#)

Recommend electrician evaluate and repair.

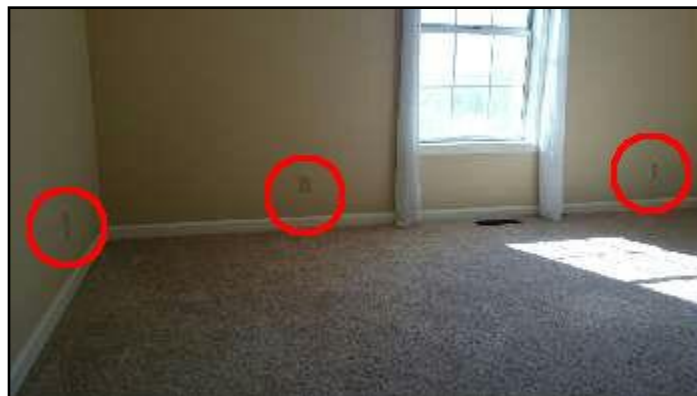
14. Condition: • [Reversed polarity](#)

25. Reversed polarity

Recommend electrician evaluate & repair these receptacles.

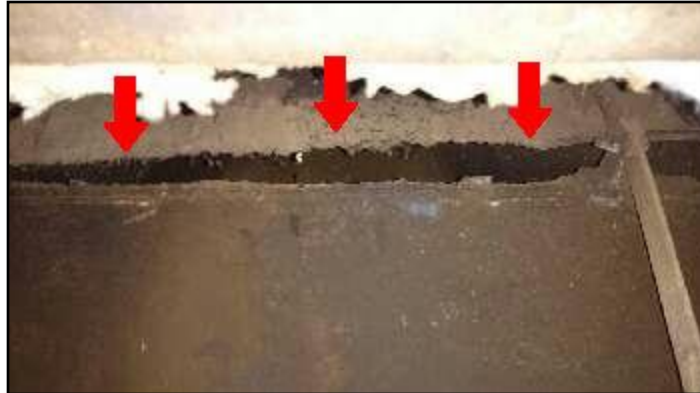
15. Condition: • [Damper or frame rusted](#)

Implication(s): Hazardous combustion products entering home | Increased heating costs | Reduced comfort

26. Damper or frame rusted

Recommend replacement of rusted damper.

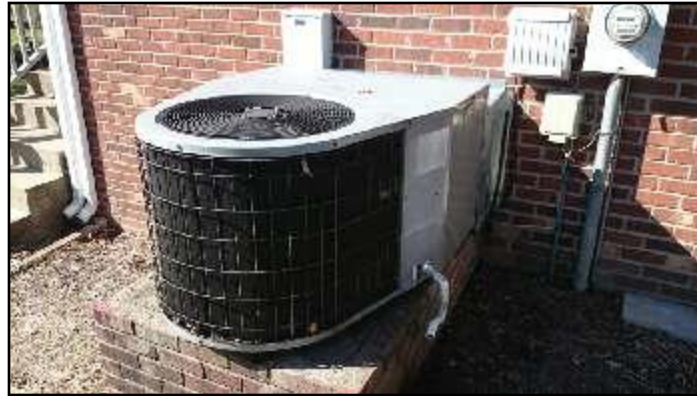
27.

Manufacturer: • Unknown! Missing tag has been removed.

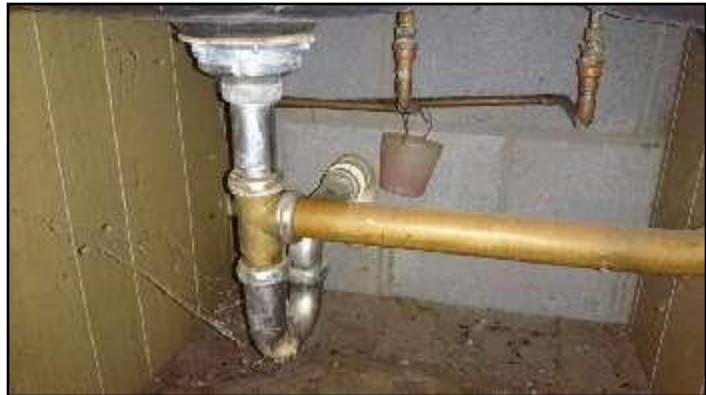
- 17. Condition:** • [Missing](#)
- Recommend plumber evaluate exhaust vent for basement sink.
- Implication(s):** Sewer gases entering the building
- Location:** Basement
- Task:** Correct

32. Missing

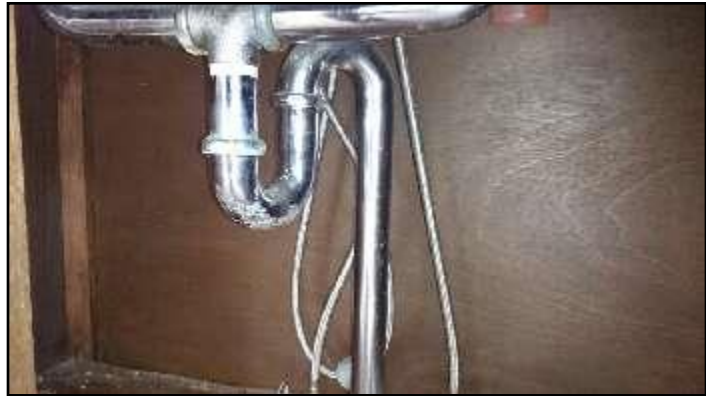
18. Condition: • [Missing](#)
Recommend plumber evaluate further. Missing ventilation on sink.
Implication(s): Sewer gases entering the building
Location: First Floor Laundry Area
Task: Provide

33. Missing

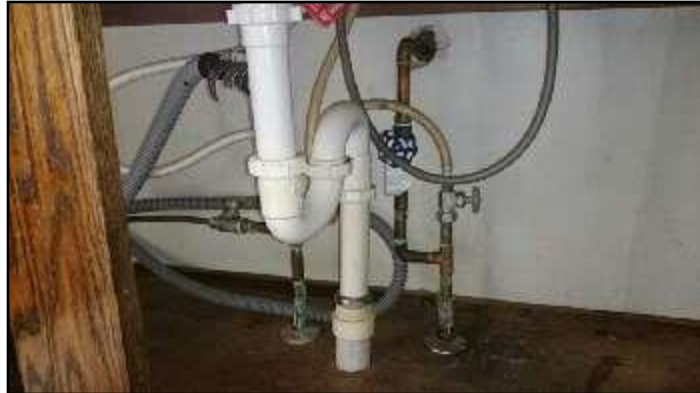
19. Condition: • [Missing](#)
Recommend plumber evaluate further. Missing ventilation on sink.
Implication(s): Sewer gases entering the building
Location: First Floor Kitchen
Task: Provide

34. *Missing*

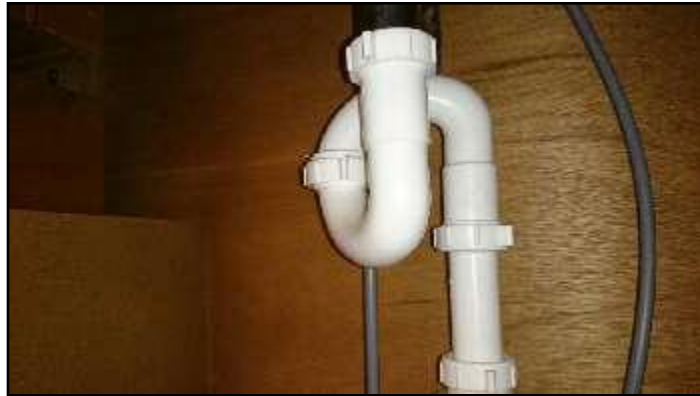
20. **Condition:** • [Missing](#)

35. *Missing*

Recommend plumber evaluate further. Missing ventilation on sink.

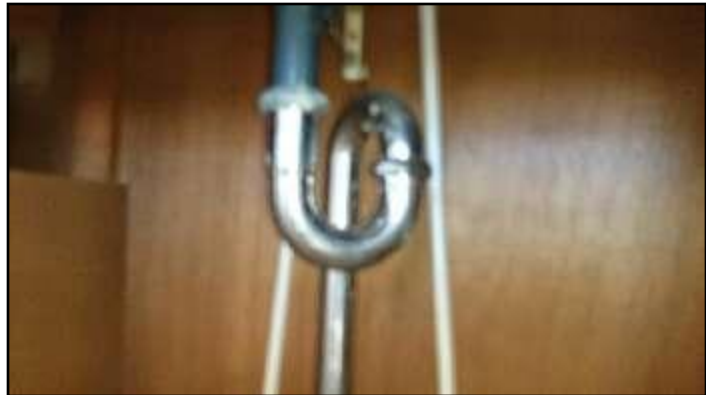
21. **Condition:** • [Missing](#)

36. Missing

Recommend plumber evaluate further. Missing ventilation on sink.

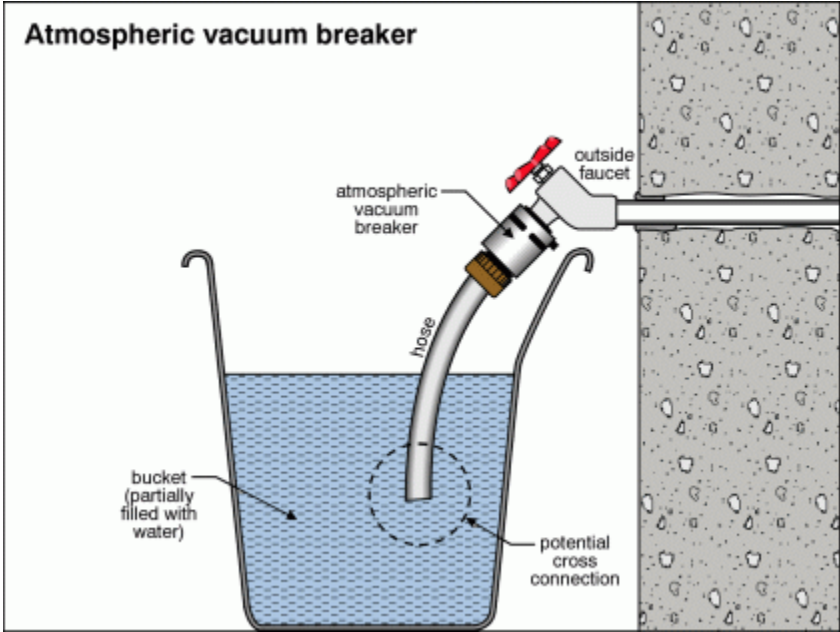
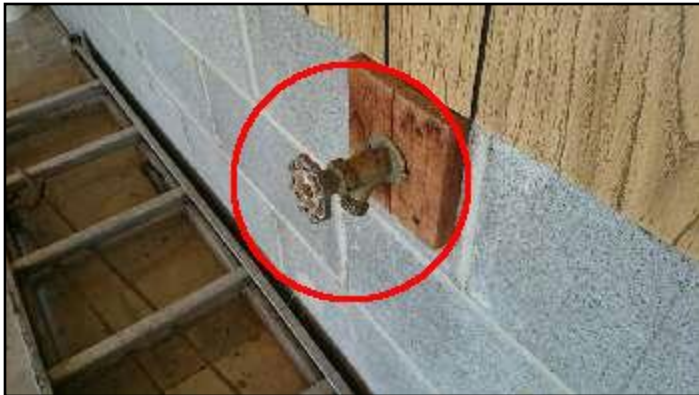
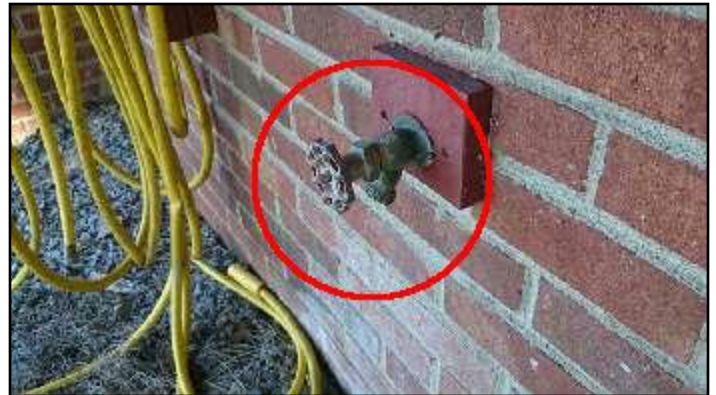
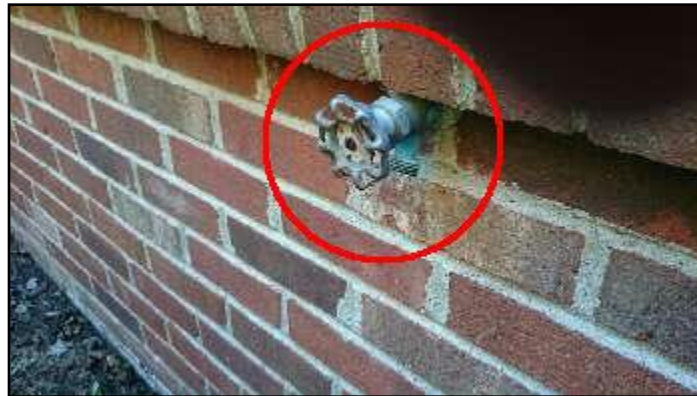
22. Condition: • [Backflow prevention missing](#)

Implication(s): Contaminated drinking water

Location: One on back of house under deck, front of house, and in garage.

37. Backflow prevention missing

Recommend anti siphon bibbs be installed to prevent cross contamination.

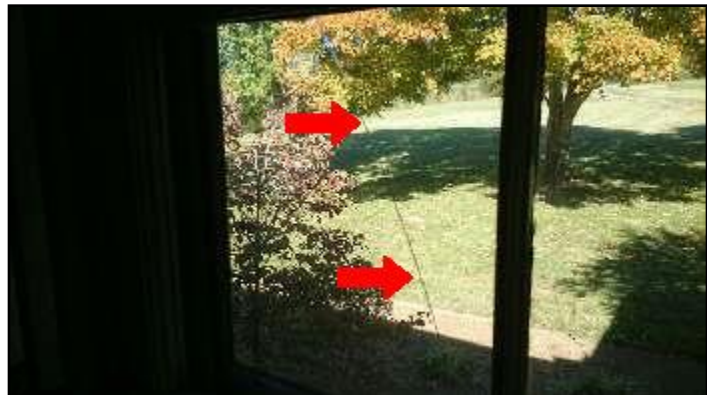
- 23. Condition:** • [Cracked](#)
Recommend replacement of storm window in dining room.
- Implication(s):** Cosmetic defects | Physical injury
- Location:** First Floor Dining Room
- Task:** Repair

40. Cracked

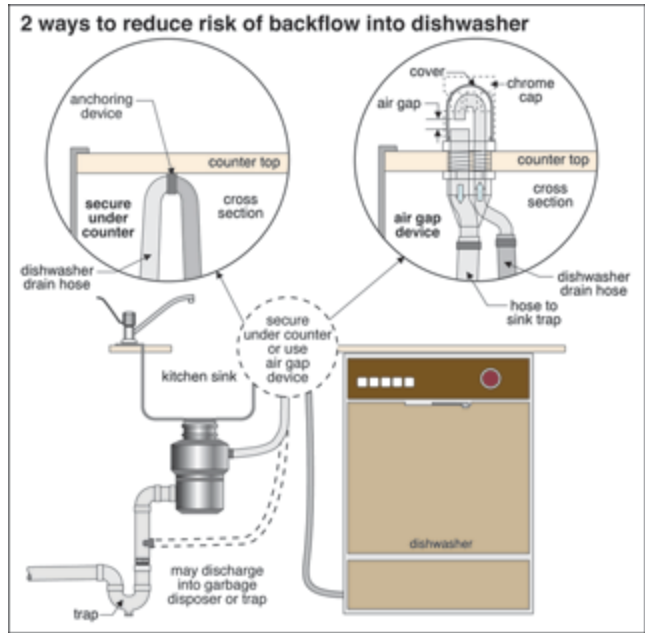
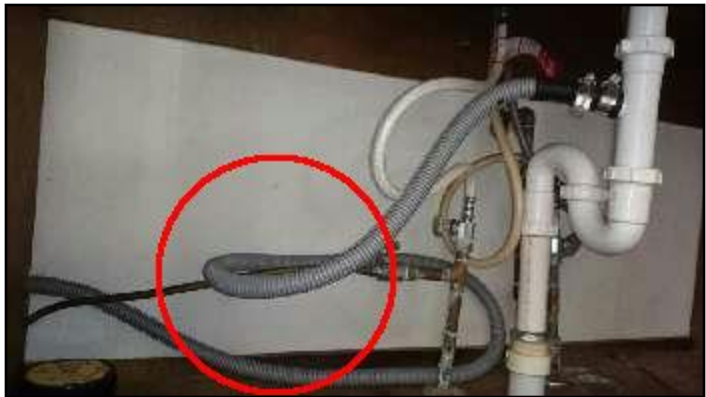
- 24. Condition:** • Backflow prevention missing
Recommend waste line from dishwasher should be vent or looped under counter to prevent cross contamination in the water.
- Implication(s):** Contaminated drinking water
- Location:** Kitchen
- Task:** Correct
- Time:** Immediate
- Cost:** Minor

41. Backflow prevention missing
