INSPECTION REPORT

For the Property at:
2720 ACADEMY RD
LEBANON , TN 37087

Prepared for: JOHN DOE
Inspection Date: Thursday, October 23, 2014
Prepared by: Harold Shelby

RE: Report No. 1018, v.2
2720 Academy Rd
Lebanon , TN
37087

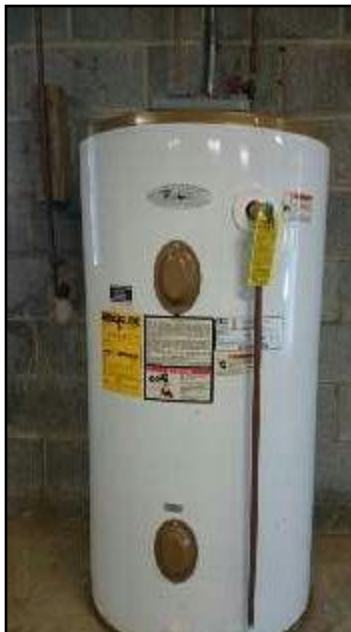
31.

- Tank capacity:** • 50 gallons
- Water heater approximate age:** • 11 years
- Typical life expectancy:** • 8 to 12 years
- Water heater failure probability:** • [Low](#)
- Hot water circulating system:** • [Present](#)
- Waste disposal system:** • [Septic system](#)
- Waste piping in building:** • [PVC plastic](#)
- Main fuel shut off valve at the:** • Garage
